**Flood Control Project Maintenance  
Levee Inspections**  
**LMA District Cover Sheet**  
**Spring 2011 Levee Inspection Results**

**City of Sacramento**

**Levee Inspection Report By Mile - Spring 2011**

Waterway	Bank	Unit Miles	Inspection Start/End	Inspector
Unit No. 01 City of Sacramento	Left	3.63	04/08/2011 04/08/2011	John Williamson

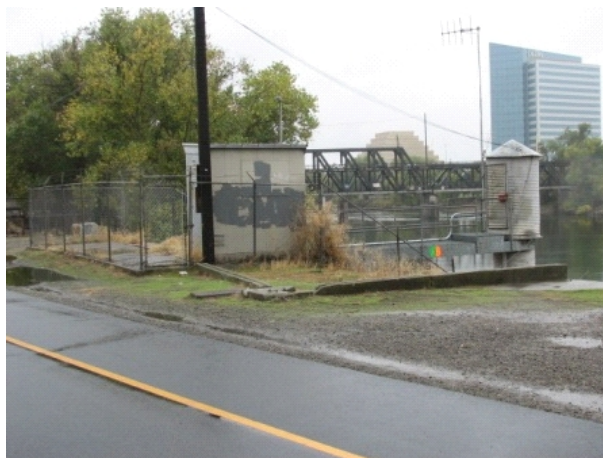
Levee Mile Report Line	1
Start Levee Mile	0.14
End Levee Mile	0.14
Location	Water Side
Category	Earthen Levee
Item	Encroachments

I Street recorder can

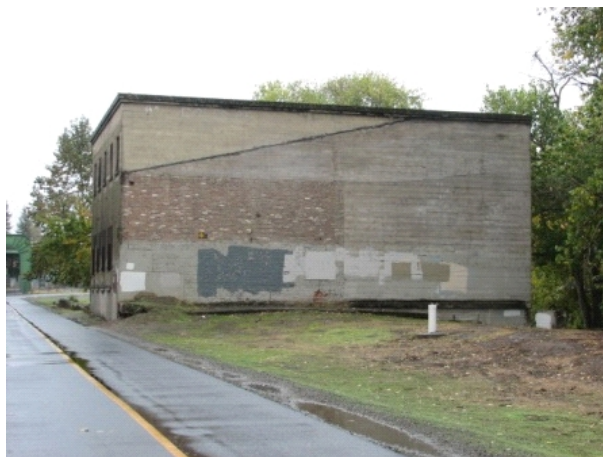
Levee Mile Report Line	2
Start Levee Mile	0.16
End Levee Mile	0.16
Location	Water Side
Category	Earthen Levee
Item	Encroachments

Historical Building with foundations and Ramps on upstream and downstream sides

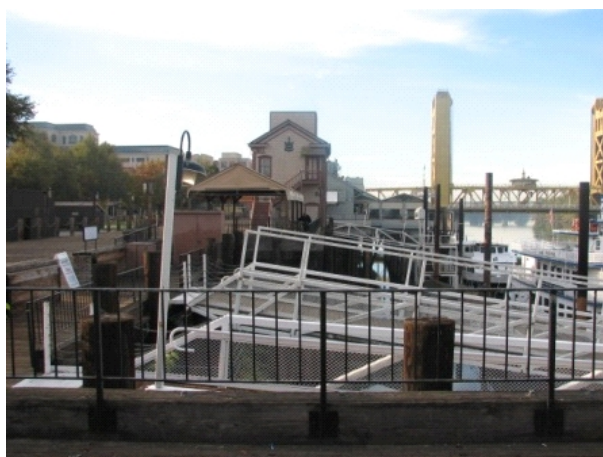
Levee Mile Report Line	3
Start Levee Mile	0.37
End Levee Mile	0.73
Location	Crown
Category	Earthen Levee
Item	Encroachments

Photo looking downstream from the Delta King of Old Sacramento.

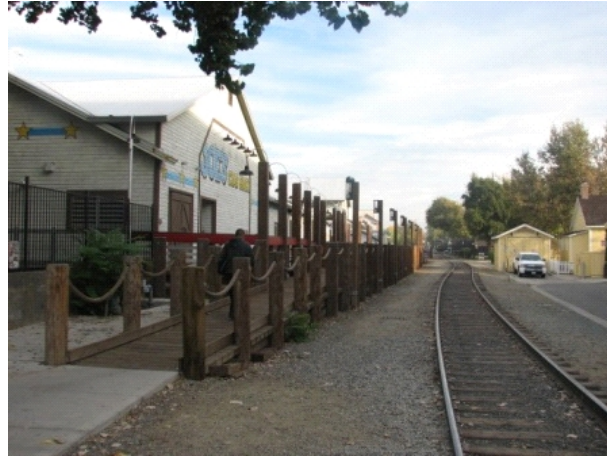
Levee Mile Report Line	3
Start Levee Mile	0.37
End Levee Mile	0.73
Location	Crown
Category	Earthen Levee
Item	Encroachments
A look at Joe's Crab Shack on the levee in Old Sacramento.	
johnngw_s_20110228_096.jpg

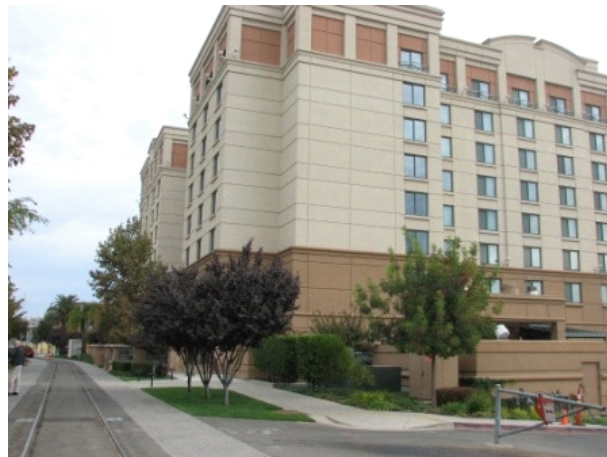
Levee Mile Report Line	4
Start Levee Mile	0.78
End Levee Mile	0.78
Location	Crown
Category	Earthen Levee
Item	Encroachments
Embassy Suites	
johnngw_s_20110228_086.jpg

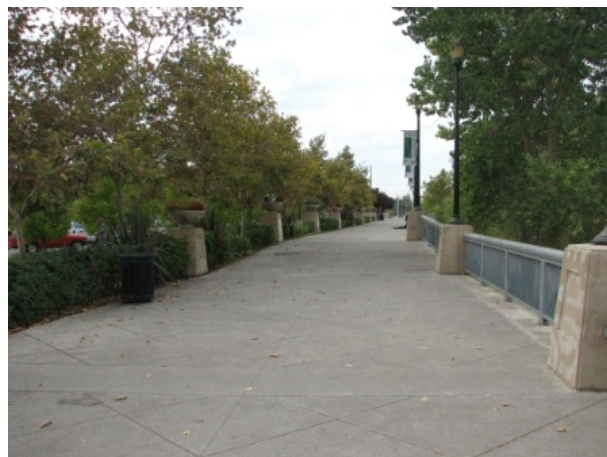
Levee Mile Report Line	5
Start Levee Mile	0.78
End Levee Mile	1.17
Location	Crown
Category	Earthen Levee
Item	Encroachments
River walk crown with landscaping	
johnngw_s_20110228_087.jpg

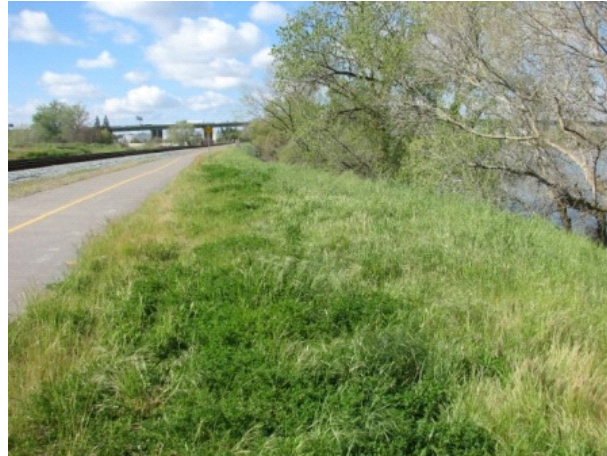
Levee Mile Report Line	6
Start Levee Mile	1.15
End Levee Mile	3.61
Location	Water Side
Category	Earthen Levee
Item	Vegetation

The photo is of the waterside levee slope. The vegetation complies with standards.

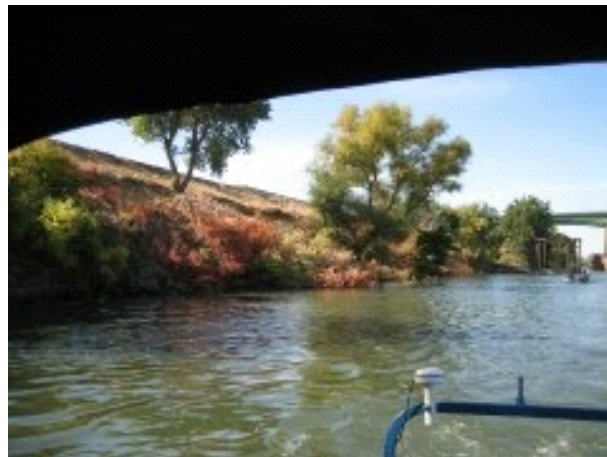
Levee Mile Report Line	7
Start Levee Mile	1.33
End Levee Mile	1.40
Location	Water Side
Category	Supplemental
Item	USACE Erosion Survey

2009: no berm, 2:1 slope, holes, sands and silts, 4.81 ft/s [2009 SiteID:SAC\_58-4\_L]

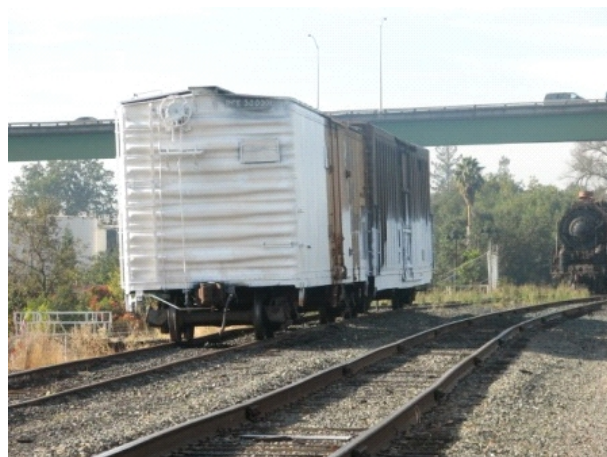
Levee Mile Report Line	8
Start Levee Mile	1.38
End Levee Mile	1.38
Location	Crown
Category	Earthen Levee
Item	Encroachments

This is the replacement of the storage bins on the railroad tracks.

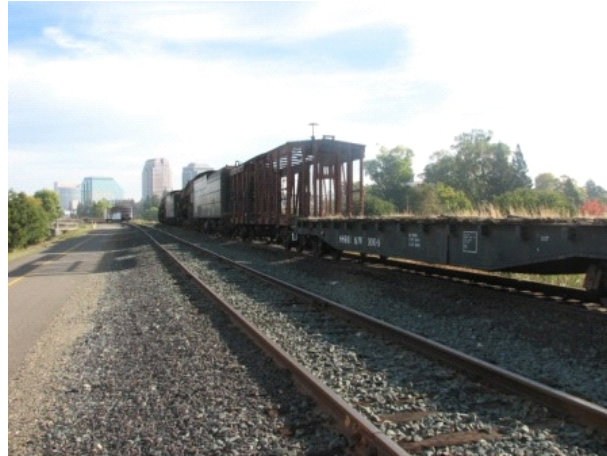
Levee Mile Report Line	9
Start Levee Mile	1.46
End Levee Mile	1.46
Location	Crown
Category	Earthen Levee
Item	Encroachments
<p>The trains that were at 1.54 have been pulled upstream to this location. The CVFPB has asked that they be removed from the levee.</p>	
<p>johngw_s_20110228_091.jpg</p>

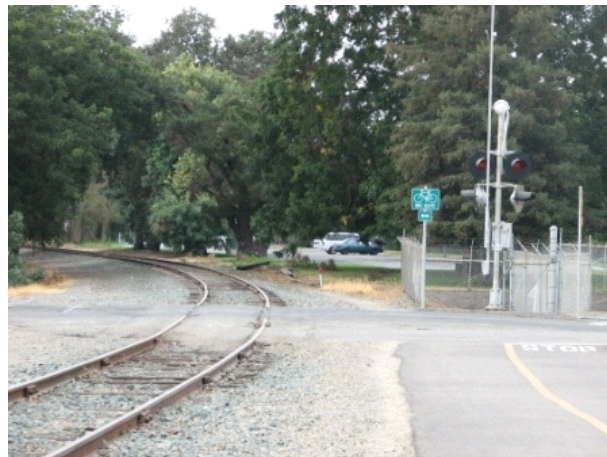
Levee Mile Report Line	12
Start Levee Mile	1.73
End Levee Mile	1.96
Location	Crown
Category	Earthen Levee
Item	Encroachments
<p>Miller Park at Broadway railroad track and parking area on levee</p>	
<p>johngw_s_20110228_088.jpg</p>

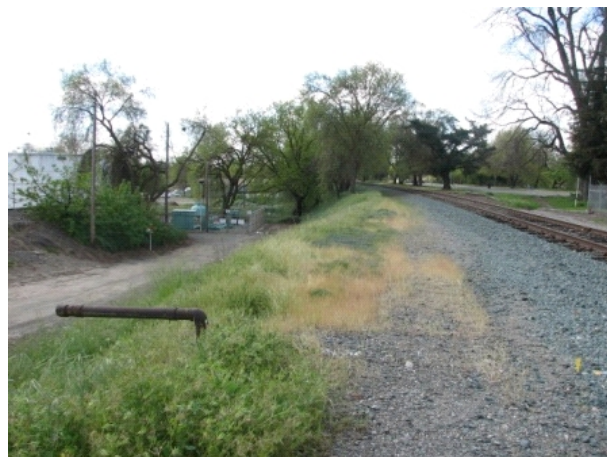
Levee Mile Report Line	13
Start Levee Mile	1.74
End Levee Mile	3.61
Location	Land Side
Category	Earthen Levee
Item	Vegetation
<p>The photo is of the landside levee slope at Miller Park. The vegetation complies with standards.</p>	
<p>johngw_s_20110411_430.jpg</p>

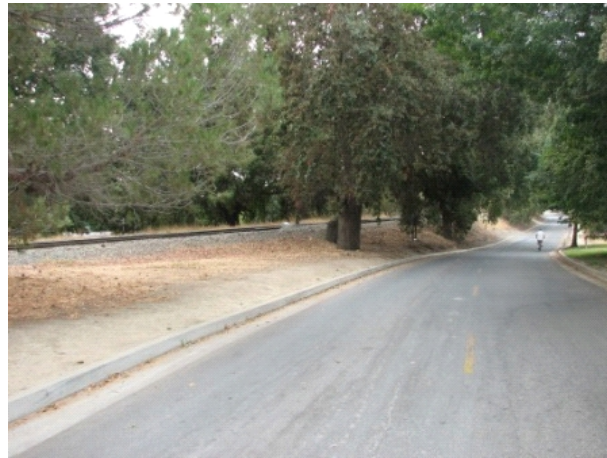
Levee Mile Report Line	14
Start Levee Mile	1.96
End Levee Mile	2.34
Location	Crown
Category	Earthen Levee
Item	Encroachments

Railroad tracks are on levee crown. The street is to the boat ramp.

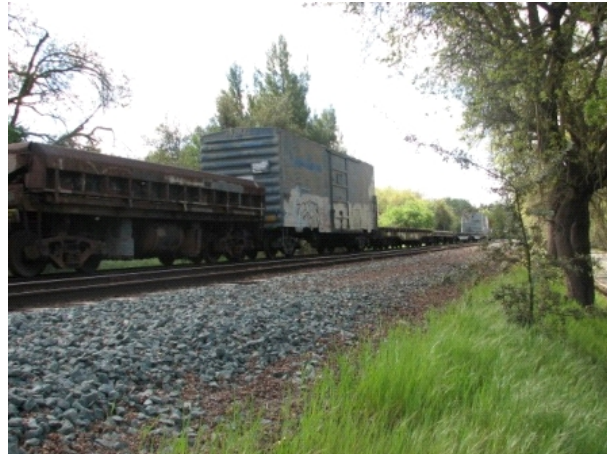
Levee Mile Report Line	14
Start Levee Mile	1.96
End Levee Mile	2.34
Location	Crown
Category	Earthen Levee
Item	Encroachments

The Railroad museum has moved the trains to this area along Miller Park.

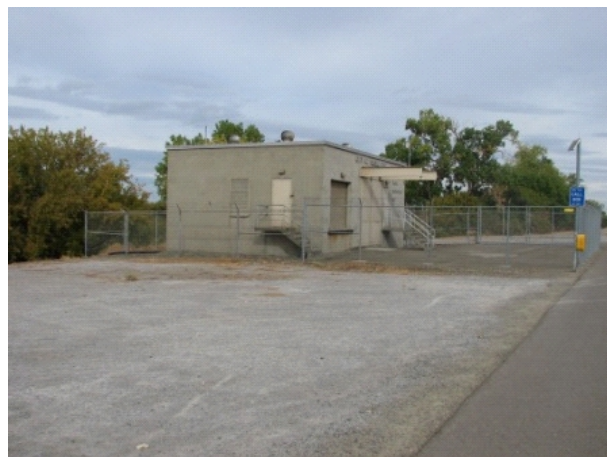
Levee Mile Report Line	16
Start Levee Mile	2.90
End Levee Mile	2.90
Location	Crown
Category	Earthen Levee
Item	Encroachments

pump station city of Sacramento crown of levee waterside
